# Operational Inspections

## **LPC1 Longden Play Area**

Memorial Hall, Shrewsbury, SY5 8EX

Thursday 24th September, 2026 Inspected by: Toby Knight

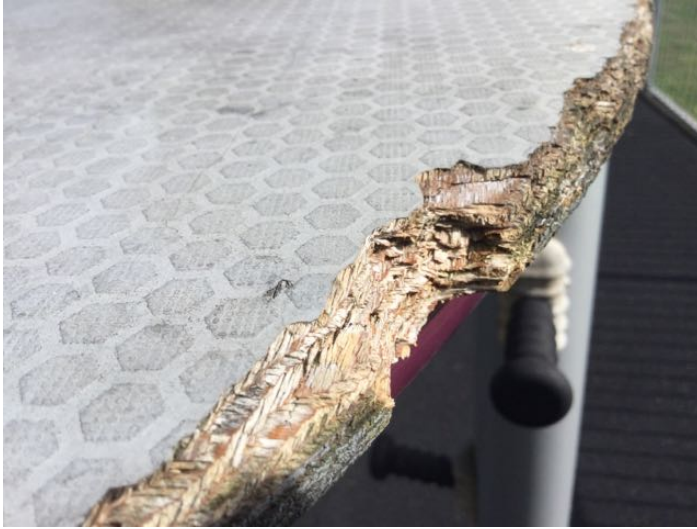
**Item name/report item:**  
MULTIPLAY PLATFORMS

Low

**Findings:**  
PLY ON PLATFORMS CHIPPED AND  
DAMAGED

**Actions:**  
REPLACE PLY

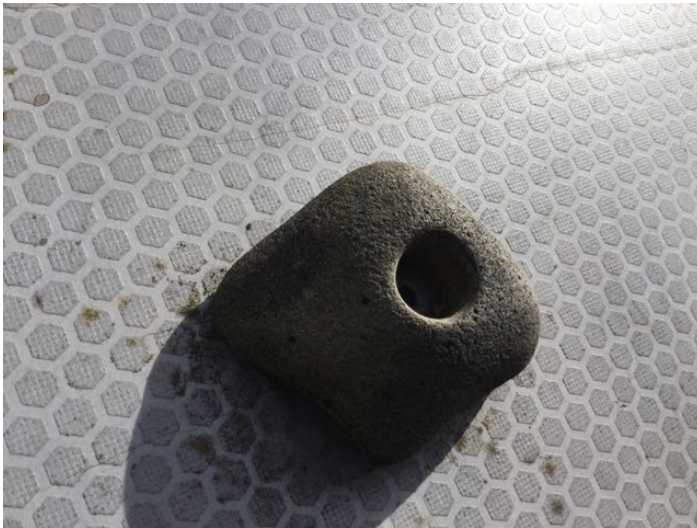
**Item name/report item:**  
MULTIPLAY CLIMBING HOLDS

Low

**Findings:**  
CLIMBING HOLDS ROTATE

**Actions:**  
TIGHTEN

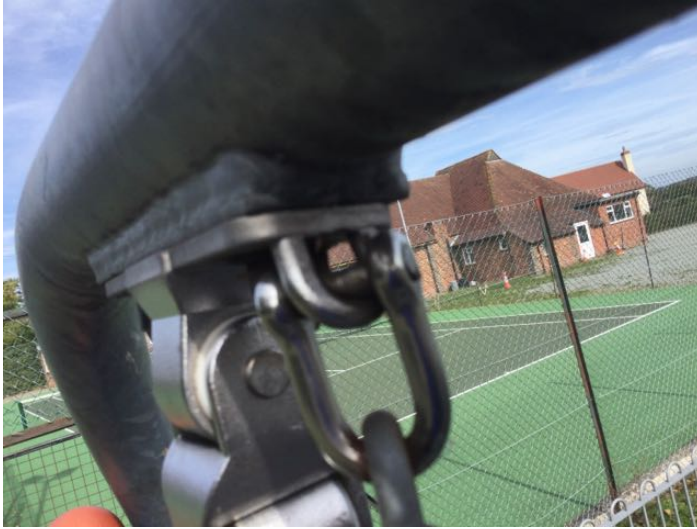
**Item name/report item:**  
SWING MIXED SAFETY CHAIN

Low

**Findings:**  
WEAR IN TOP SHACKLE OF SAFETY  
CHAINS ON BASKET SEAT

**Actions:**  
MONITOR PLAN FOR RENEWAL

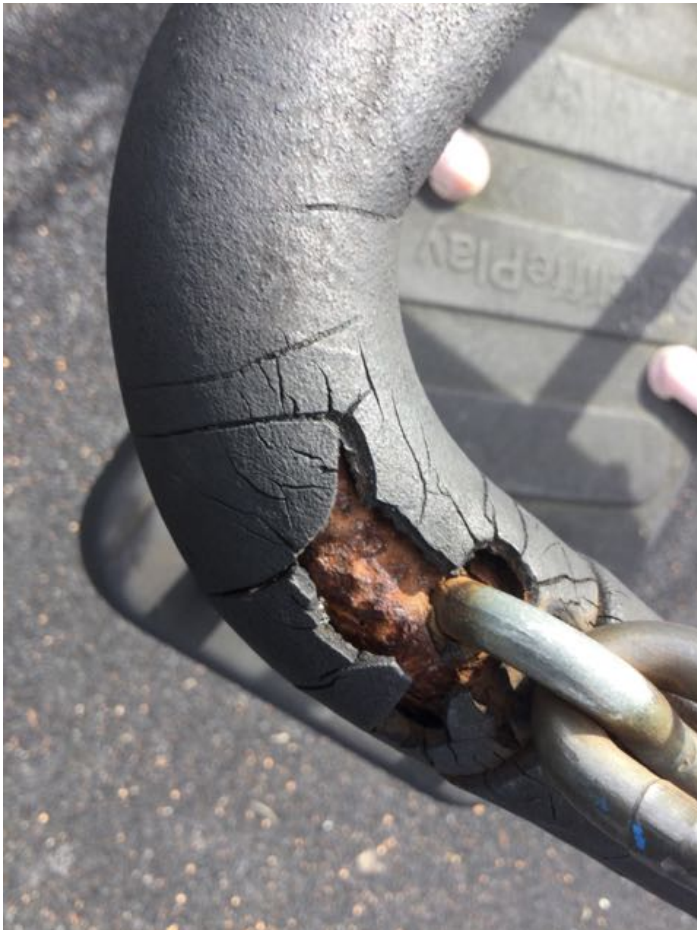
**Item name/report item:**  
SWING MIXED CRADLE

Low

**Findings:**  
TOP FRAME OF CRADLE SEAT  
CORRODED

**Actions:**  
REPLACE CRADLE SEAT
