# the play inspection company

## Annual Inspection

Shropshire Council

Longden Play Area

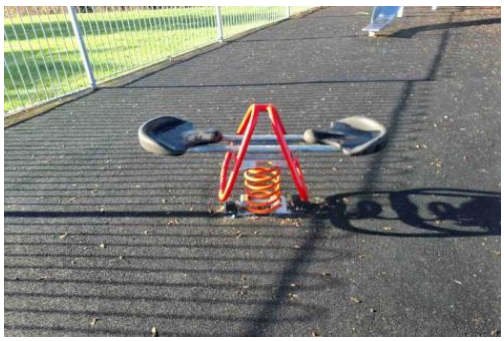
**Item:** Spring See-Saw
**Manufacturer:** Sutcliffe Play Limited
**Surface Type:** Wet Pour
**Item Quantity:** 1
**Equipment Compliance:** Yes
**Surface Area Compliance:** Yes

The spring clamps are loose - Tighten all loose fixings
